## Don Baker RV Inspections - Exterior

2011 Jayco Pinnacle 36REQS

<b>Actions</b>	11
<b>DATE</b>	19.08.2024
RV INSPECTION PERFORMED BY CERTIFIED RV INSPECTOR / COMPANY: Don Baker RV Inspections LLC	
<b>RV YEAR, MAKE, MODEL:</b>	2011 Jayco Pinnacle 36REQS
<b>RV INSPECTION CLIENT:</b>	Aldo Landin
<b>RV VIN NUMBER:</b>	1UJCJ0BU9B1RB0197
<b>RV INSPECTION LOCATION:</b>	100 Robinson Park Dr. Llano, TX 78643

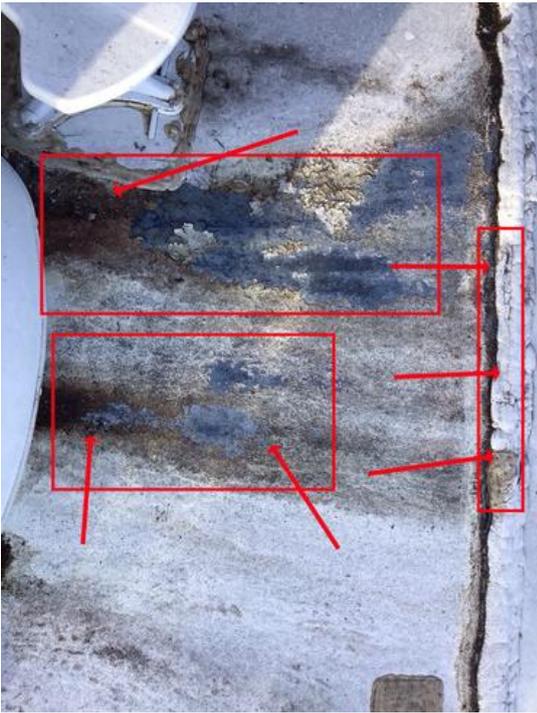
Photo 11

The roof material toward the front end of the RV is deteriorating and dissolving.

It is recommended the entire roof be examined by a qualified RV technician to determine if repair or replacement is necessary.

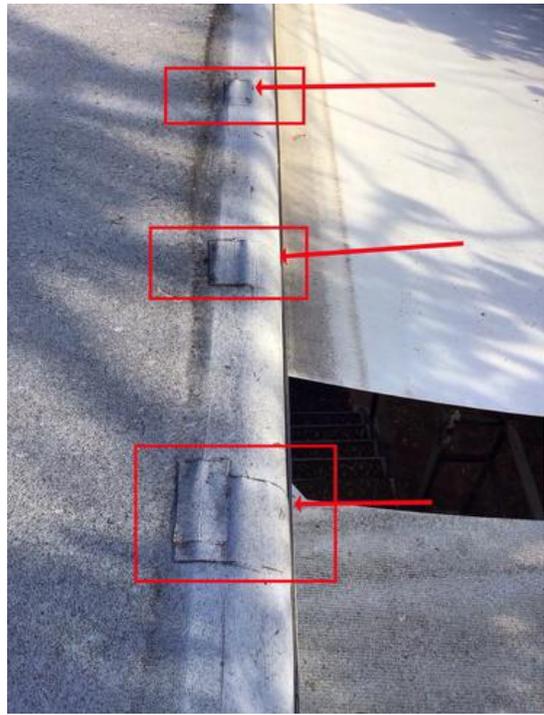
Photo 14

There are multiple areas where it appears some form of repair was attempted.

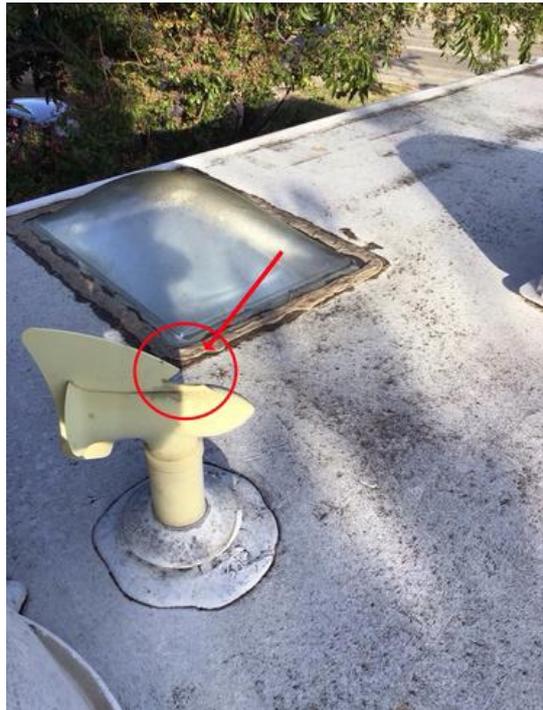
Photo 20

The plumbing vent exhibits a broken piece of fin.

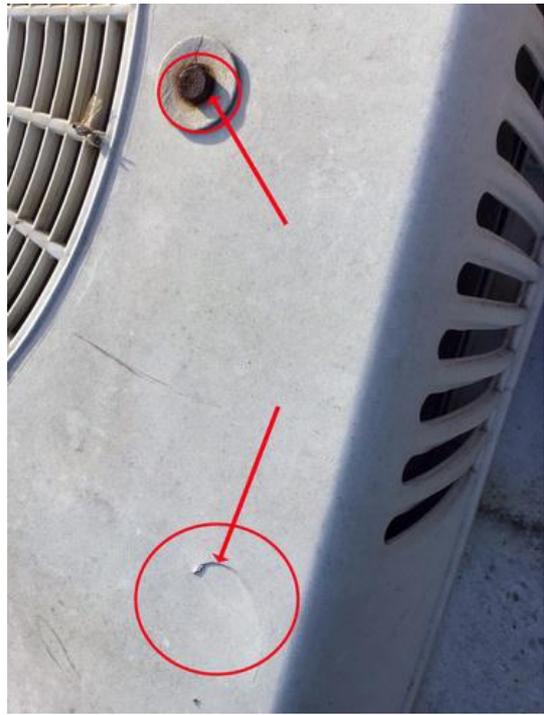
Photo 22

There is a small crack in the front A/C shroud, and a rusty screw.

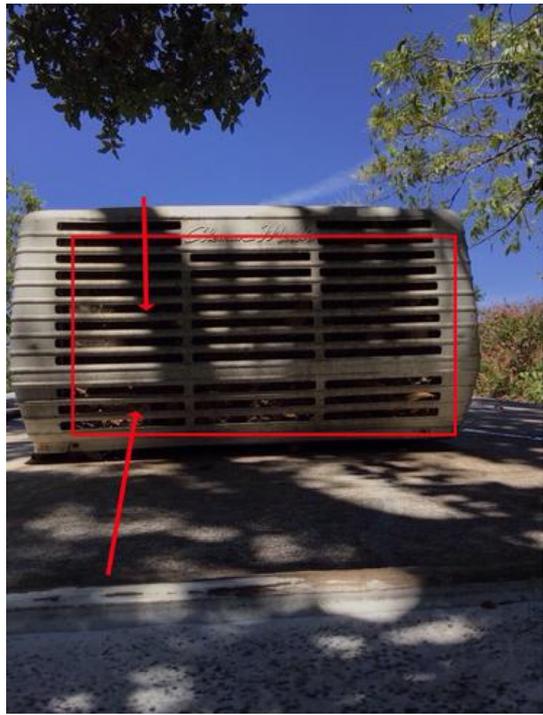
Photo 26

Coils are dirty and have leaves in shroud.

It is recommended all the area around the AC coil be cleaned, and all debris removed for proper airflow.

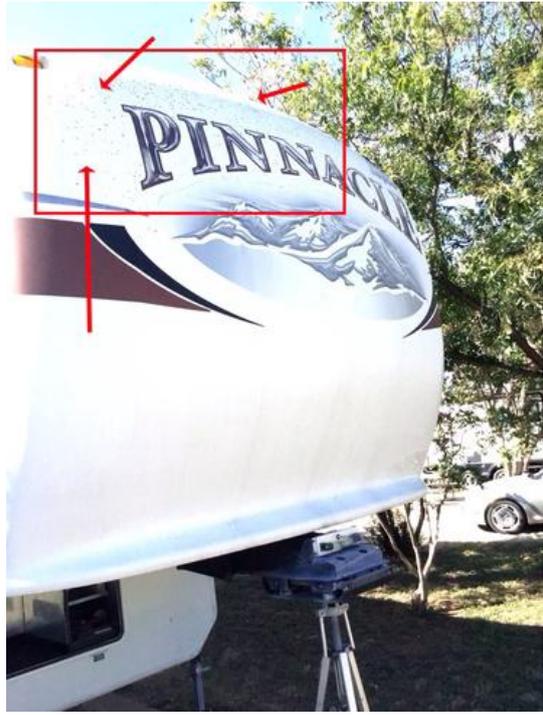
Photo 54

There are mold spots due to the environment elements on the top of the front end.

It is recommended the entire RV roof, front end and rear end all be washed thoroughly with the proper cleaning solution to read all evidence of environmental debris.

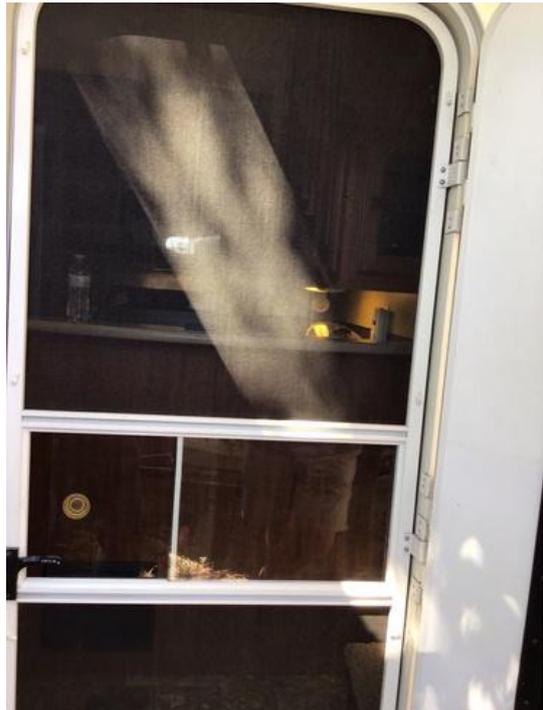
Photo 72

The screen door exhibits two separate tears in the screen.

It is recommended the screen door be repaired or replaced to prevent bug intrusion.

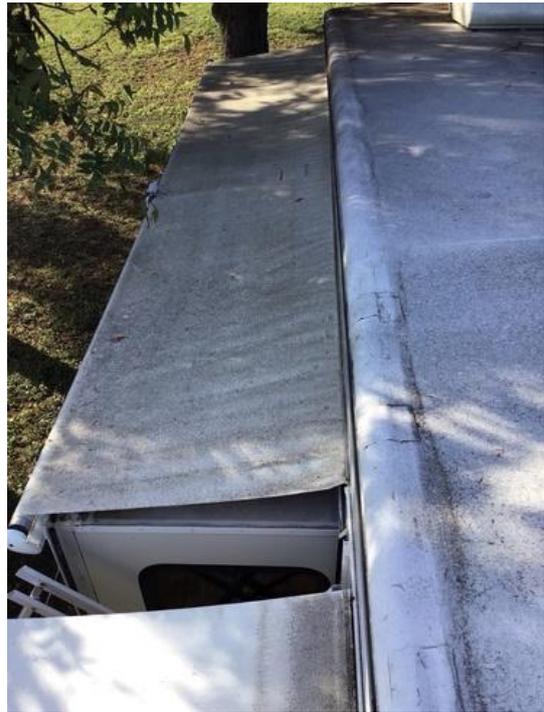
Photo 76

The slide out topper exhibit two areas of decay or cracking.

It is recommended the two areas of cracking in the slideout Topper be repaired with awning tape.

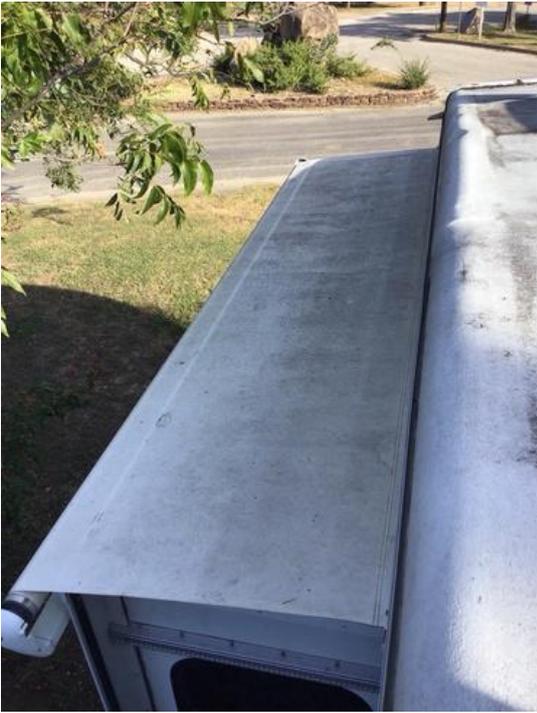
Photo 85

The slide out topper exhibit cracking in multiple places.

It is recommended to slide out topper be repaired with awning tape.
