## Don Baker RV Inspections - Exterior

2011 Jayco Pinnacle 36REQS

<b>Actions</b>	11
<b>DATE</b>	19.08.2024
RV INSPECTION PERFORMED BY CERTIFIED RV INSPECTOR / COMPANY: Don Baker RV Inspections LLC	
<b>RV YEAR, MAKE, MODEL:</b>	2011 Jayco Pinnacle 36REQS
<b>RV INSPECTION CLIENT:</b>	Aldo Landin
<b>RV VIN NUMBER:</b>	1UJCJ0BU9B1RB0197
<b>RV INSPECTION LOCATION:</b>	100 Robinson Park Dr. Llano, TX 78643

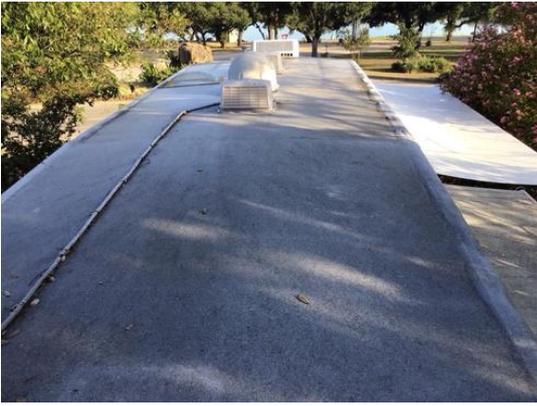
Photo 9

The roof material toward the front end of the RV is deteriorating and dissolving.

It is recommended the entire roof be examined by a qualified RV technician to determine if repair or replacement is necessary.

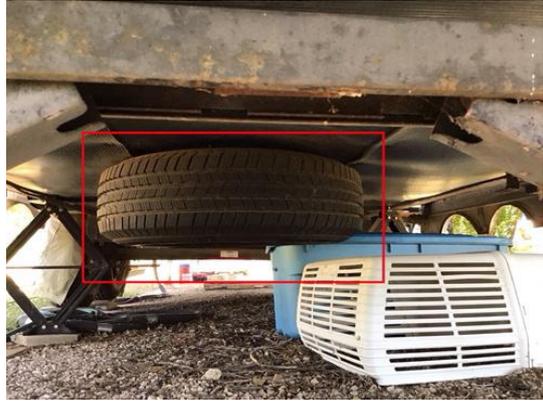
Photo 97

For your safety, DISCOUNT TIRE recommends you replace any tire that is in service 8 years or more past the date of manufacture.

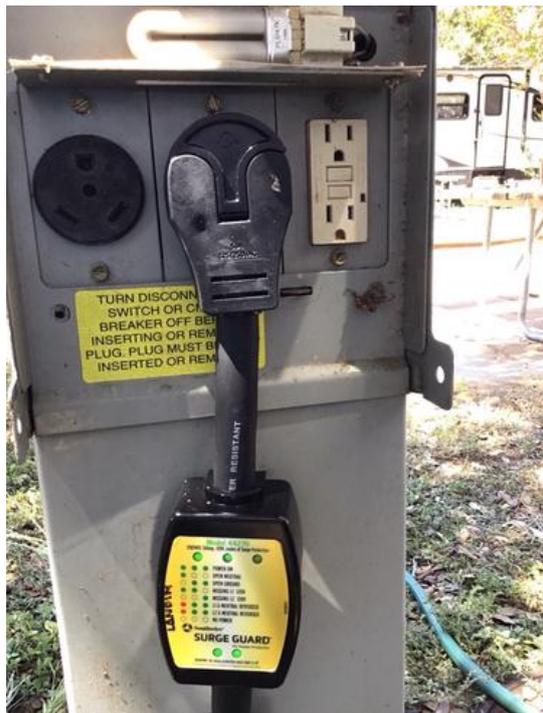
Photo 99

For proper operation of the air conditioner, AC voltage must stay between 103.5 VAC and 126.5 VAC. Operation of the unit outside of this voltage range can result in component damage.
